HOUSATONIC RIVER BASIN  
WASHINGTON, MASSACHUSETTS

FARNHAM RESERVOIR DAM  
MA 00314

PHASE I INSPECTION REPORT  
NATIONAL DAM INSPECTION PROGRAM

FEBRUARY 1980

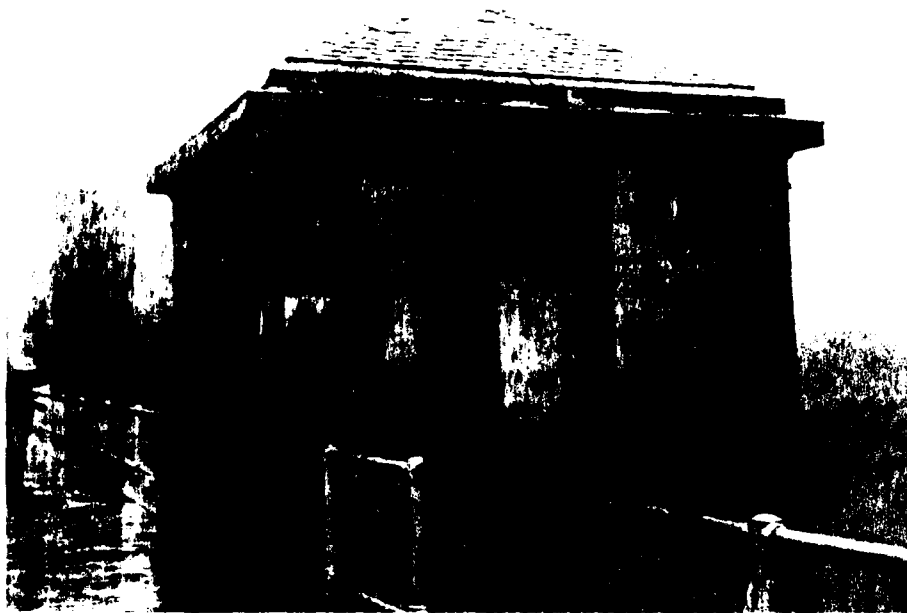
Photo 7

The gate house was found in poor condition. The walls above window sill height have tipped out about 1/4 inch on all sides and cracked above the window lintels. The gate house floor appeared to be in good condition as were the gate operating hand wheels which were secured from unauthorized operation by a steel cable and lock.

General view of gate house  
exterior condition.
